Field Report for Airborne Data Collected In Support of US EPA Region VI Intercontinental Terminals Company LLC Fire 21 March 2019

Data Results Flight 5, 21 March 2019

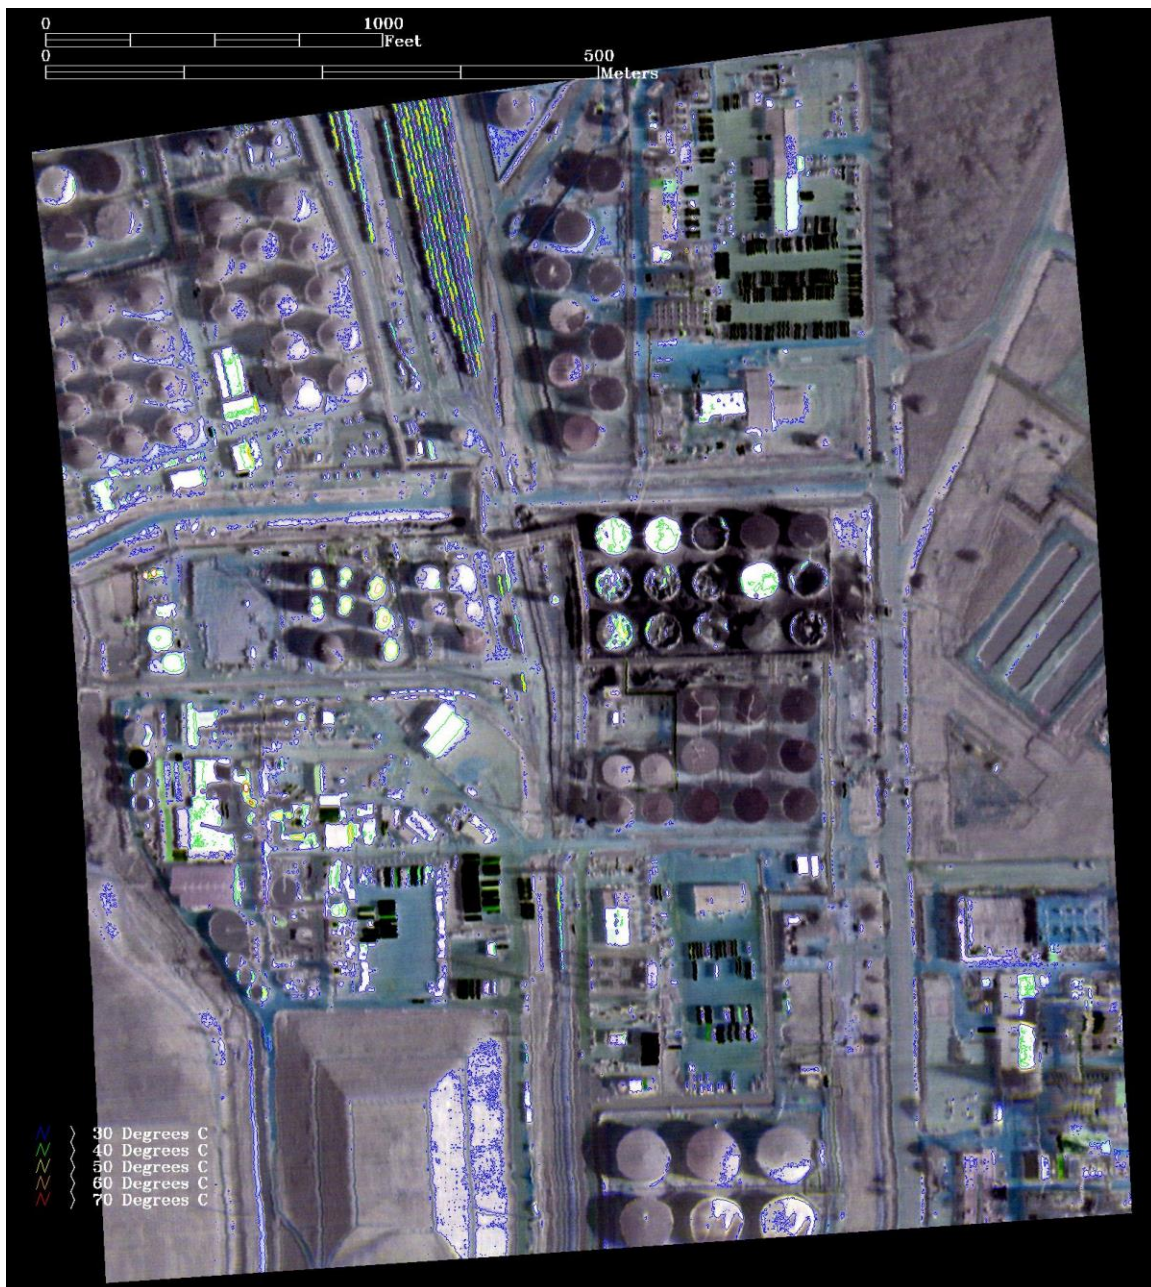
Figure 3: IR and Thermal analysis of ITC data for 21 March 2019, Run 2

A total of 1 test and 20 data passes were made in the proximity of the impacted tank farm and also in extended areas surround the site and an infrared line scanner images were generated for each pass. Figure 3 shows a typical 3-band infrared image obtained from data collected for Run 5. Examination of the IR image shows a typical industrial scene. Thermal contours are included on the image and show that the tank farm is essentially at approximately 30 °C. It should be noted that process units in the general area are warmer than the tank farm. No plumes were detected in the image.

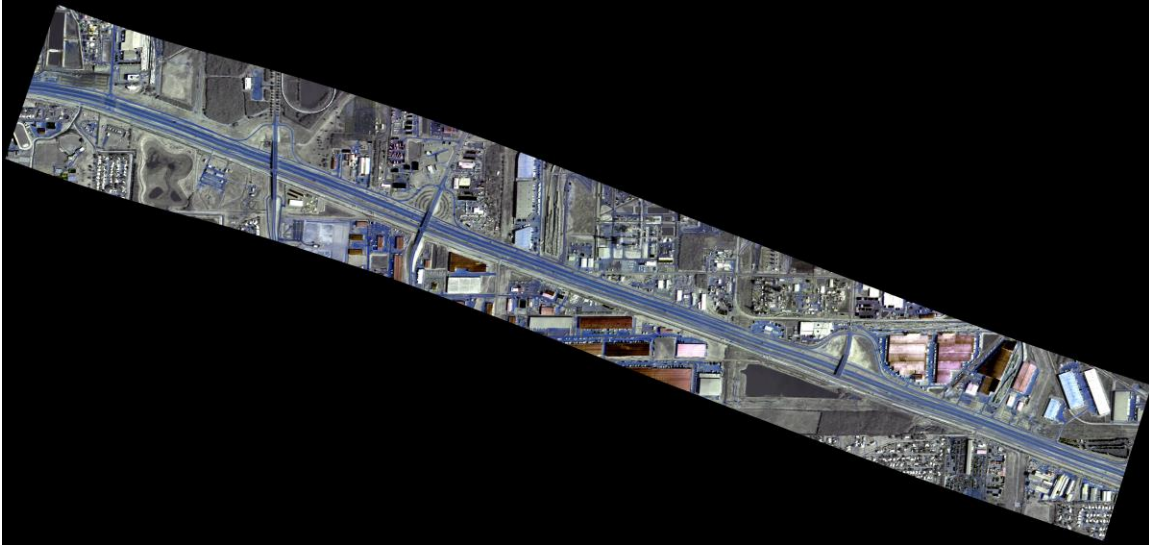
Figure 4: IR image along highway 225, 21 March 2019, Run 11

In addition to a focus near the tank farm, ASPECT also conducted a general patrol in extended areas surround Deer Park. Figure 4 is a representative example of a long line scanner collection (Run 11) along highway 225. Analysis of the image showed no unusual signatures.

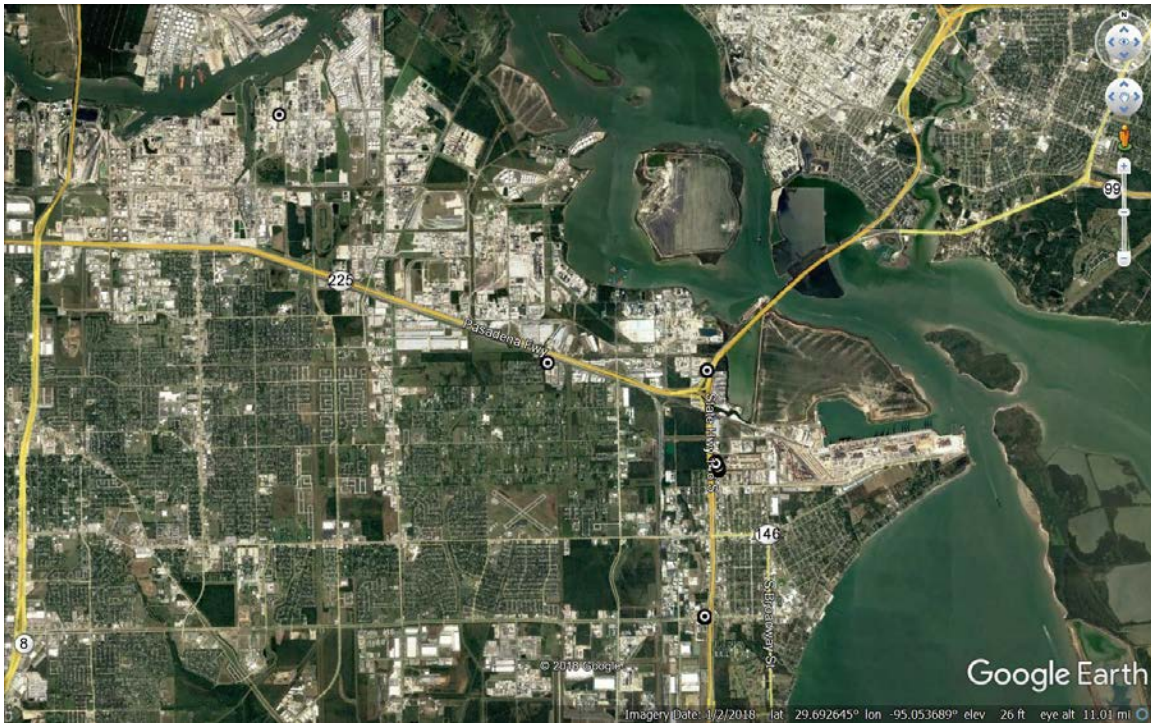
Figure 5: ITC Fire, Chemical Detection Locations – 20 March 2019

An examination of FTIR data collected on this mission showed low level detections in the general vicinity around the tank farm (Figure 5). These detections included both acetone and isobutylene at levels less than about 1 ppm. Based on the wind direction these detections are likely associated with the normal atmosphere of the urban area.

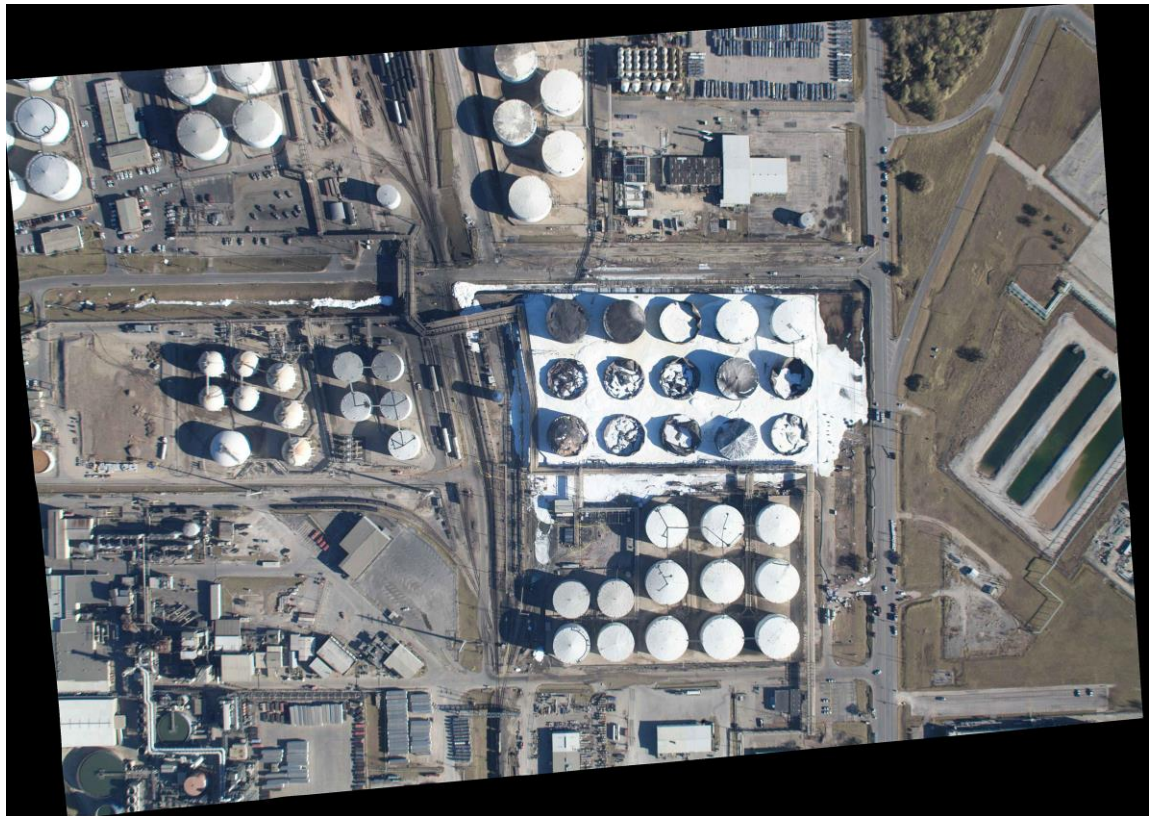
Figure 6: Aerial Image of the ITC Tank Farm, Flight 5

A full set of high resolution aerial digital photography were collected as part of the flight. Figure 6 shows a representative overhead image collected as part of each pass. As evident in the image, the fires associated with the tank farm are absent. In addition, the secondary containment area of the tank farm appears to be filled with a white substance. Figure 7 illustrates a typical oblique image. Both images confirm the finding that the fire has been extinguished and that the secondary containment is filled with a white substance.
